Manhole Inspection Summary

Manhole # S29MM_014MH

Insp Date: **7/17/07 9:50 AM**

Location Address: **700 RESERVOIR ST**

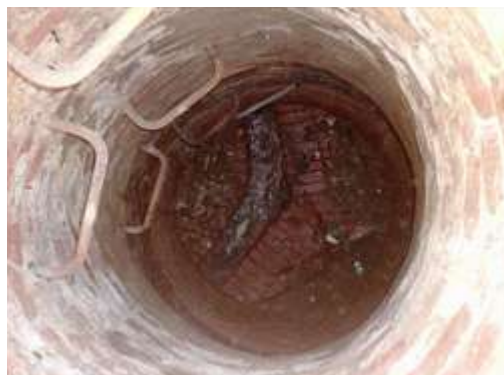
Top View

Corroded steps. Evidence of surcharge - Bench debris.

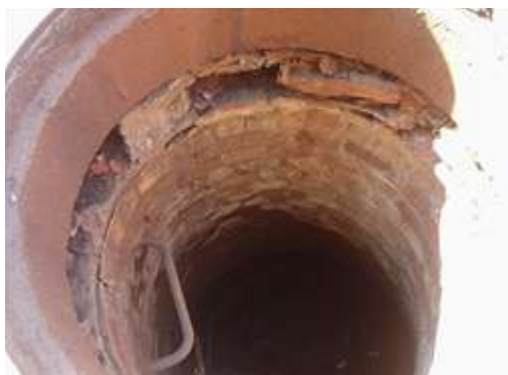
Defect

Frame leaks. Adjustment deterioration, loose brick and infiltration. Corbel and Barrel infiltration - other side.

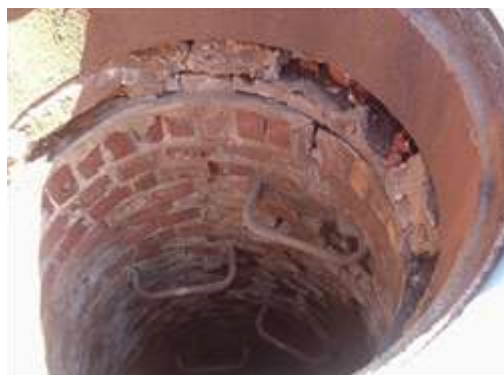
Defect

Frame leaks. Adjustment deterioration, loose brick and infiltration. Corbel and Barrel infiltration.

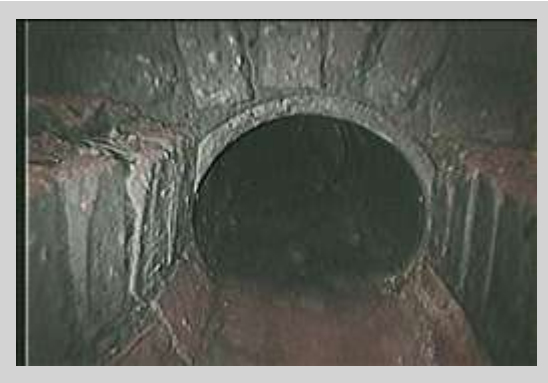
Pipe Out @ 12 O'Clock

Pipe Material: **Clay** ☐ Pipe Lined

Invert Depth: **12.10** (ft.) Flow Characteristics: **Fast**

Deposits: ☒ None ☐ Mud ☐ Sludge ☐ Debris ☐ Grease

Infiltration: **None** Pipe Seal Cond: **Unknown**

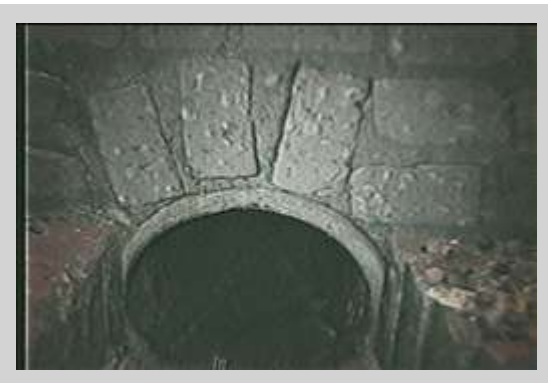
Pipe In @ 7 O'Clock

Pipe Material: **Clay** ☐ Pipe Lined

Invert Depth: **11.95** (ft.) Flow Characteristics: **Fast**

Deposits: ☒ None ☐ Mud ☐ Sludge ☐ Debris ☐ Grease

Infiltration: **None** Pipe Seal Cond: **Unknown**
